# FECHNICAL BULLETIN

This bulletin describes how to correctly install new firmware in the revision 1 10 inch Uniplay.

10 inch Uniplay HMI with revision 1 hardware. This does NOT affect any 7 inch HMIs. It does not affect the revision 2 10 inch Uniplay HMI.

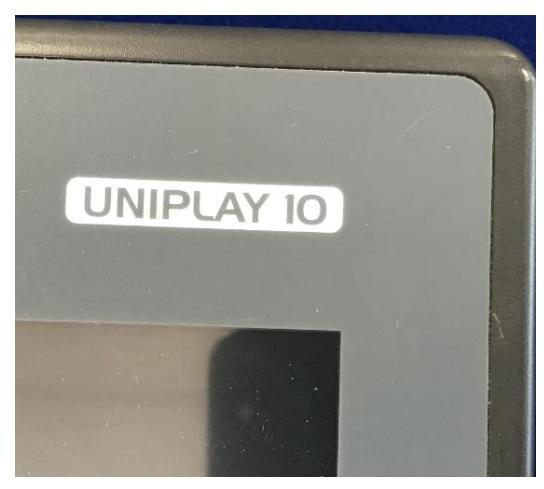
10 inch Uniplay Revision 1.

There is an issue that will cause 10 inch hardware revision 1 to fail after the update.

Dark Grey back panel and border:

For the 10 inch HMI revision 1, with the dark grey case, you MUST select Uniplay 7" (P843) as shown above.

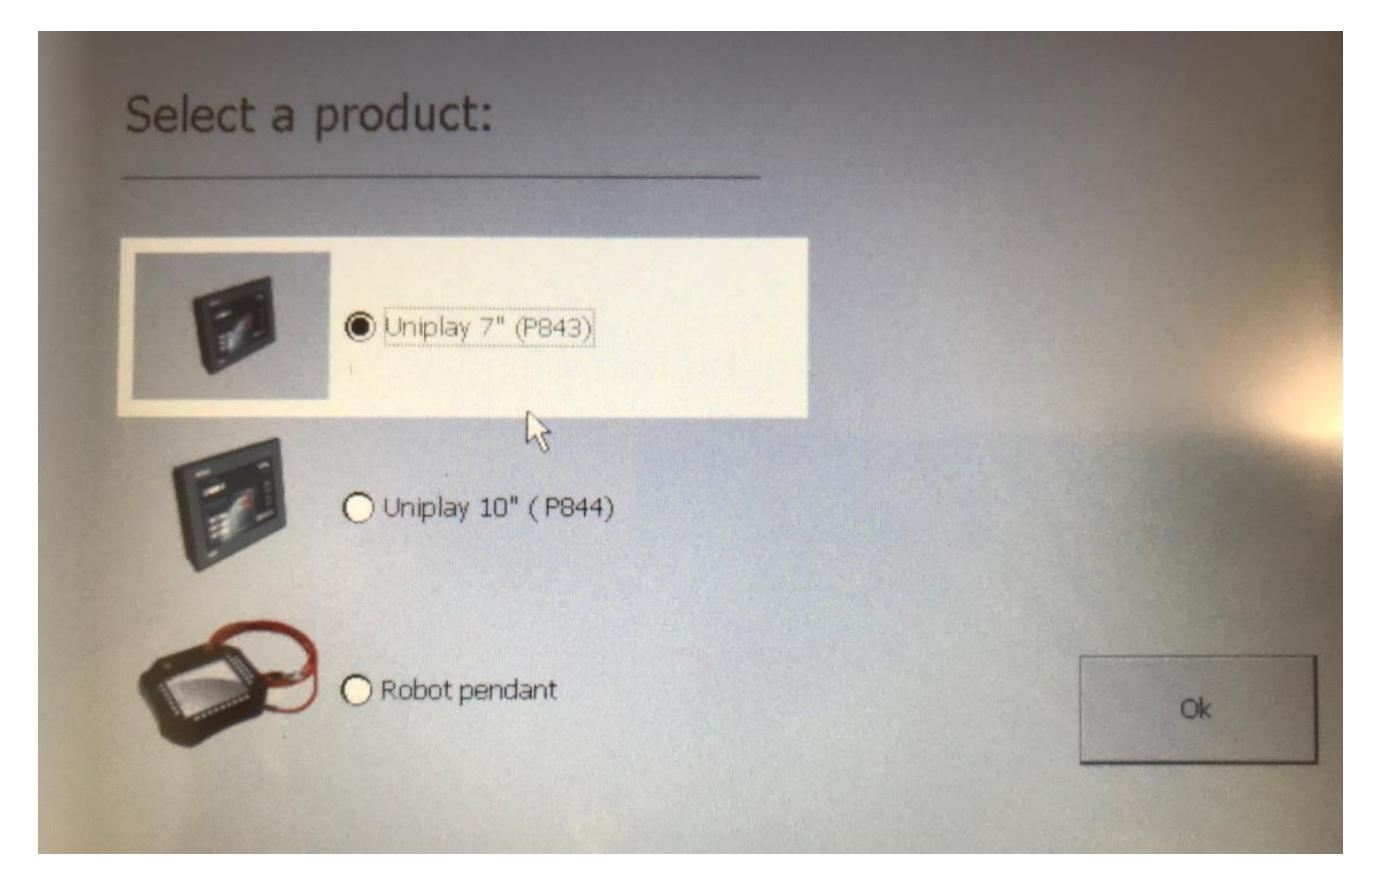
Run the update from Motion Perfect v4 in the normal way, following the prompts on screen in Motion Perfect. When the update is nearly finished, the HMI will display a choice of terminal types.
